Manhole Inspection Summary

Manhole # S21M1_010MH

Location Address: **3210 hollins ferry rd**

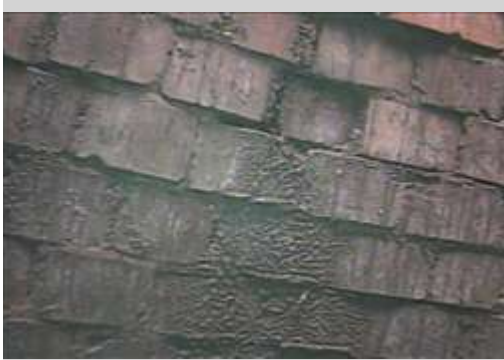
Defect 2

Infiltration: ☐ None ☐ Joint ☐ Cracks ☐ Mortar ☐ Roots ☒ **Wall**

infiltration @ barrel wall

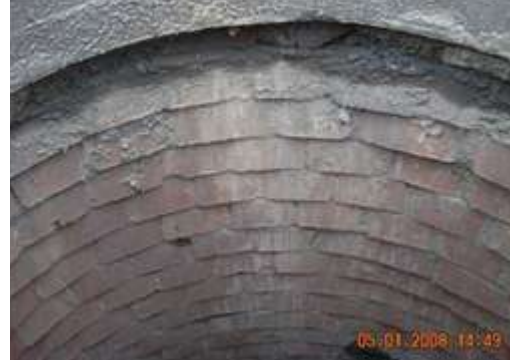
Defect 1

Infiltration: ☐ None ☒ **Joint** ☐ Cracks ☐ Mortar ☐ Roots ☐ Wall

infiltration @ chimney/frame joint

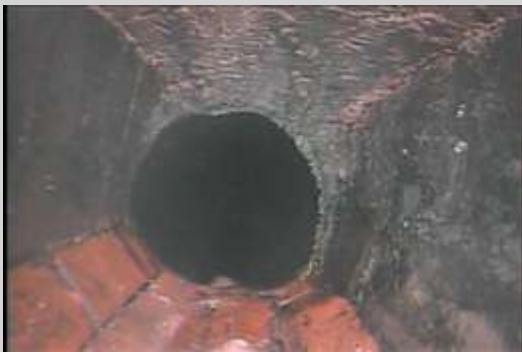
12 O'Clock Outflow

8 in. Circular Gravity Sewer
Pipe Out @ 12 O'Clock

Pipe Height: **8.4** (in.) Rod and Bar (Angled)
Pipe Material: **Clay** ☐ Pipe Lined
Invert Depth: **9.85** (ft.) Flow Characteristics: **Slow**
Deposits: ☒ None ☐ Mud ☐ Sludge ☐ Debris ☐ Grease
Silt Depth: **0** (in.) Deposits Extent:
Infiltration: **None** Pipe Seal Cond: **Sound**

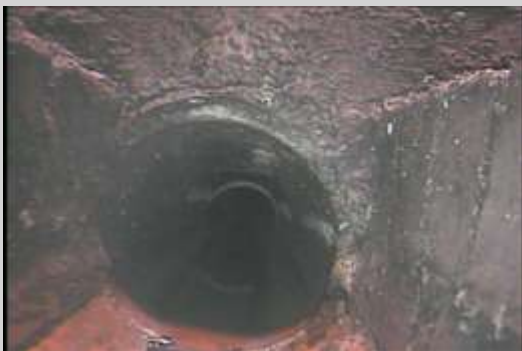
6 O'Clock Inflow

8 in. Circular Gravity Sewer
Pipe In @ 6 O'Clock

Pipe Height: **8.4** (in.) Rod and Bar (Angled)
Pipe Material: **Clay** ☐ Pipe Lined
Invert Depth: **9.64** (ft.) Flow Characteristics: **Slow**
Deposits: ☒ None ☐ Mud ☐ Sludge ☐ Debris ☐ Grease
Silt Depth: **0** (in.) Deposits Extent:
Infiltration: **None** Pipe Seal Cond: **Sound**
